GE Transportation Systems
Repair Specification

Guidelines for Ductile Iron Repair by Metal
Locking
GEVO SERIES MAIN FRAME

Device ID: GEVO12, GEVO16
Device Name: Diesel Engine – Main Frame
Quantity:

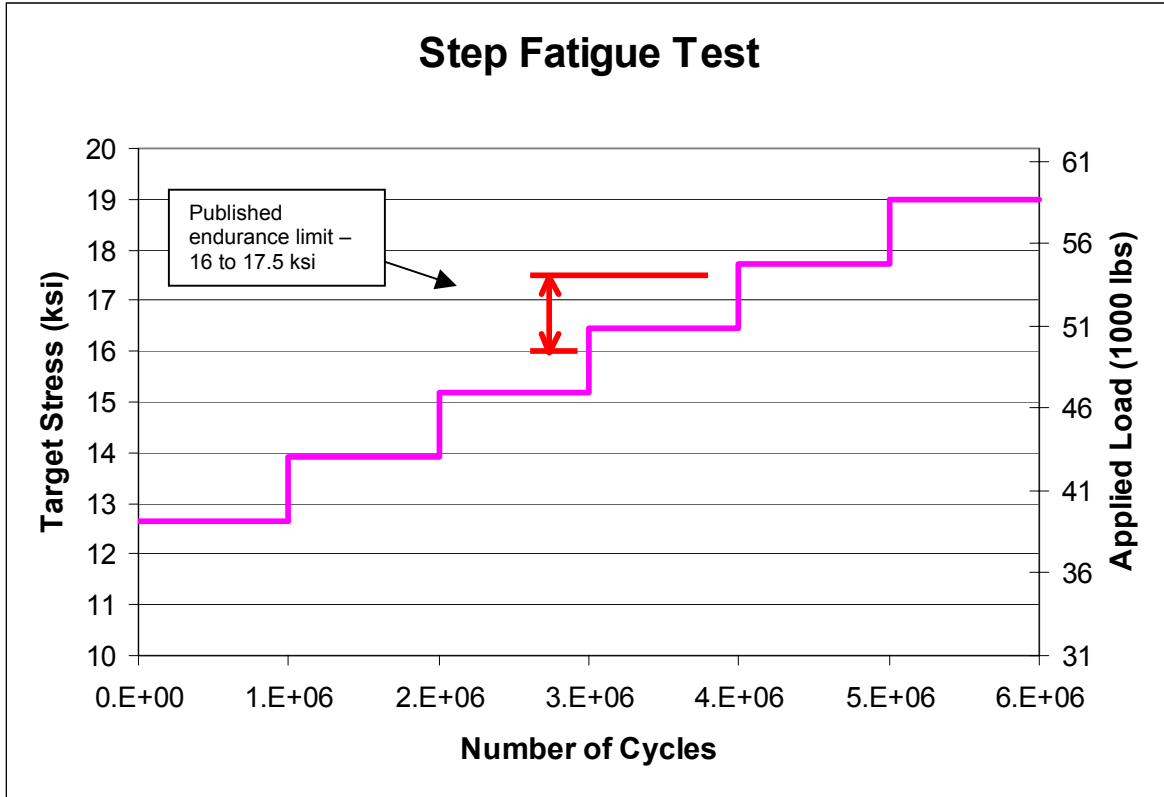
Figure 1: Example of step fatigue test showing published endurance limit range for material

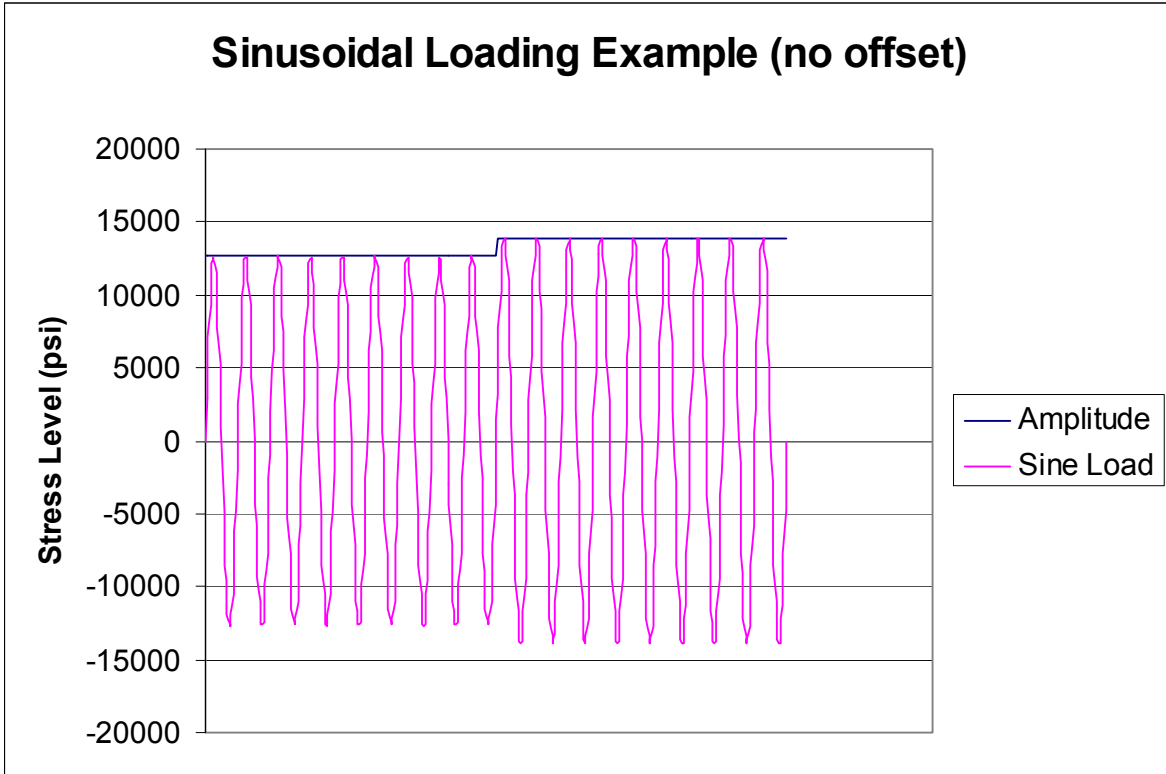
Figure 2: Example of loading with zero offset
